Subject: Remediation System Shutdown Operations - Deliverable ID 15296-16 (Contingency)
Thriftway 220, 609 E. 20th, Farmington, New Mexico
Facility ID: 29521 Release ID: 2035 WPID: 15355

REMEDIATION SYSTEM SHUT-DOWN PHOTOGRAPHS (April 30, 2009)
Thriftway 220, FARMINGTON, NM

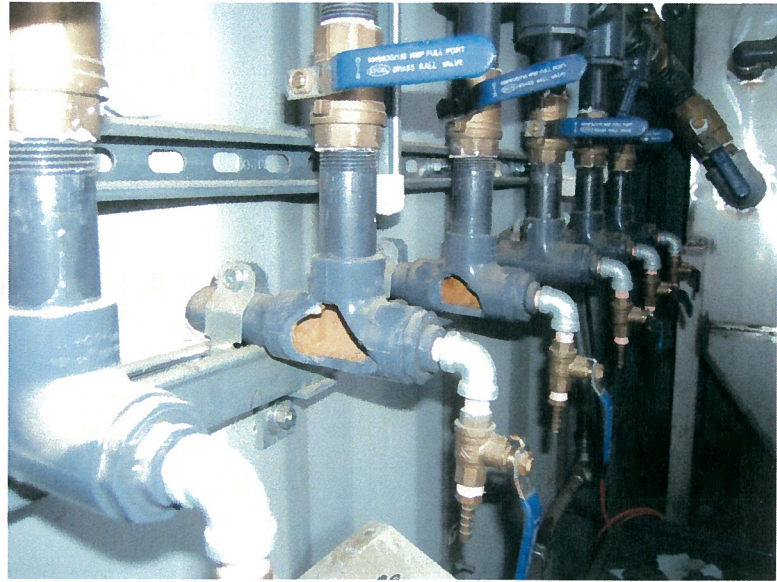
- Checked the condition of the interior/exterior piping. Fittings and pipes for MPE-5, MPE-5, and RW-2 were broken and will require repair. No other visible breaks were observed.

Photo 2 – Broken Fittings (View North-West)

- Repair broken fittings and pressure test all pipes conveying water.
- Flush the air stripper with clean water.
- Remove and dispose NAPL from storage tank.
- Test scale inhibitor metering pump with clean water prior to connection of scale inhibitor.

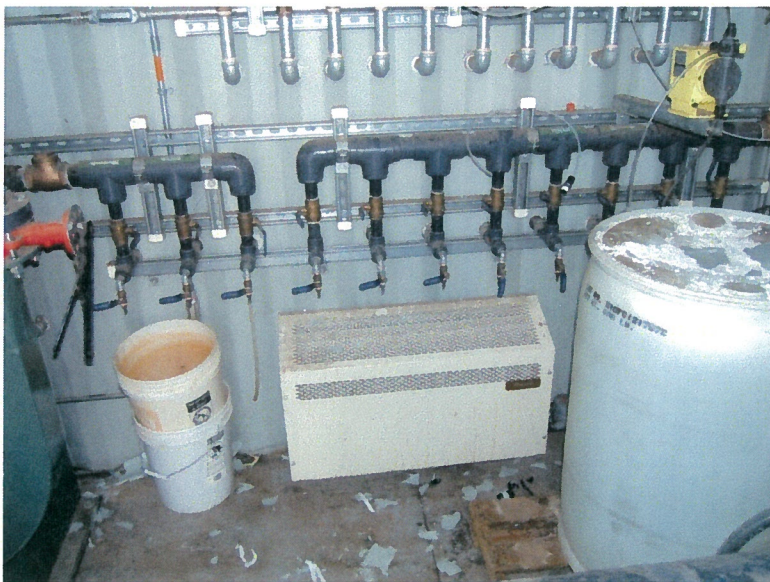
Photo 3 – Building Interior (View West)

- Replace building interior heater unit (See Photo 3) with a unit manufactured to perform in humid environments.
- Check the entire electrical system function after the SVE blower is connected.
- The interior paint in the steel building is flaking (See Photo 3) and will need to be scrubbed with a wire brush to remove the loose paint and re-coated.

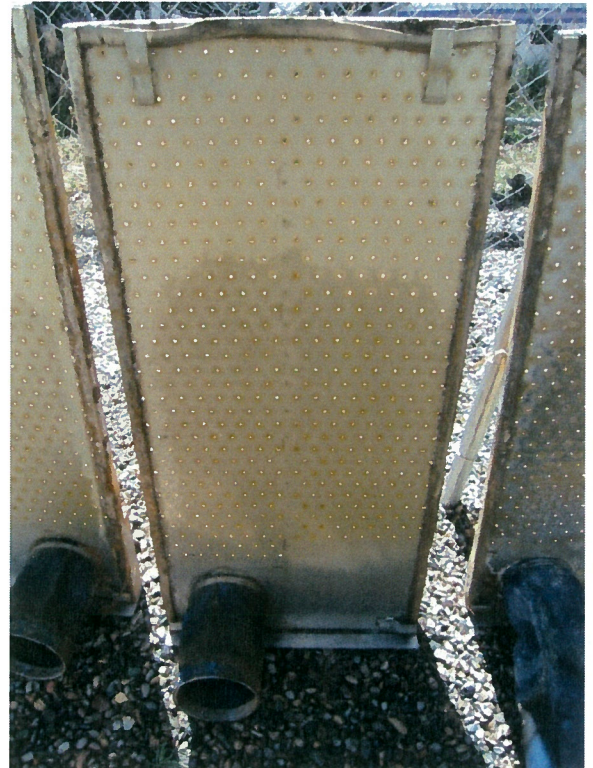
- Disposal of several empty plastic containers (approximately 1-gallon each).
- Removal and inspection of air stripper trays. The trays were in good conditions with some scale but none of the holes were clogged. The trays were rinsed with water and replaced (See Photo 3). The sump was drained of water and rinsed.

Photo 4 – Cleaned Air Stripper Trays
